ANALYSIS OF DAMAGE FROM HISTORIC TORNADO IN JOPLIN, MISSOURI, U.S.A. ON MAY 22, 2011

TECHNICAL COMMITTEE

TILT-UP CONCRETE ASSOCIATION

Report 201-12-01

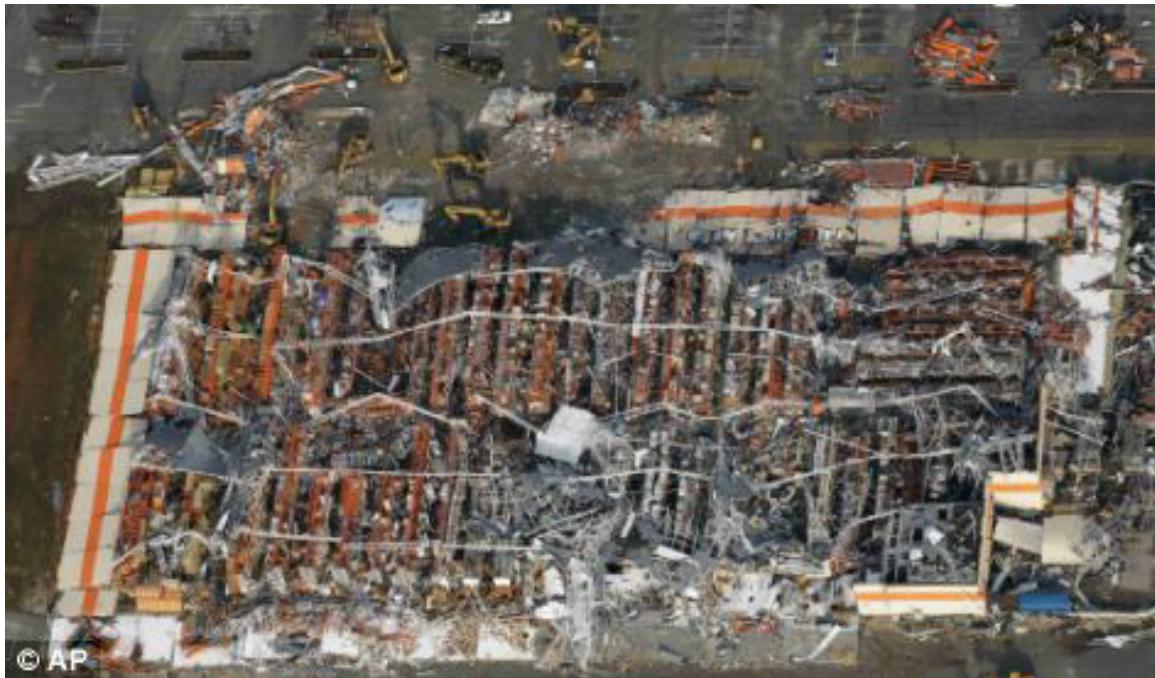
Figure 2 - Home Depot - Image Credit, Associated Press

The Home Depot building was a complete collapse as shown in Figure 2. It should be noted that numerous photographs show the panels survived intact and the failures of the panels and their connections to the roof system occurred as a secondary result of falling, not as a primary failure due to wind load. This is a very important distinction.

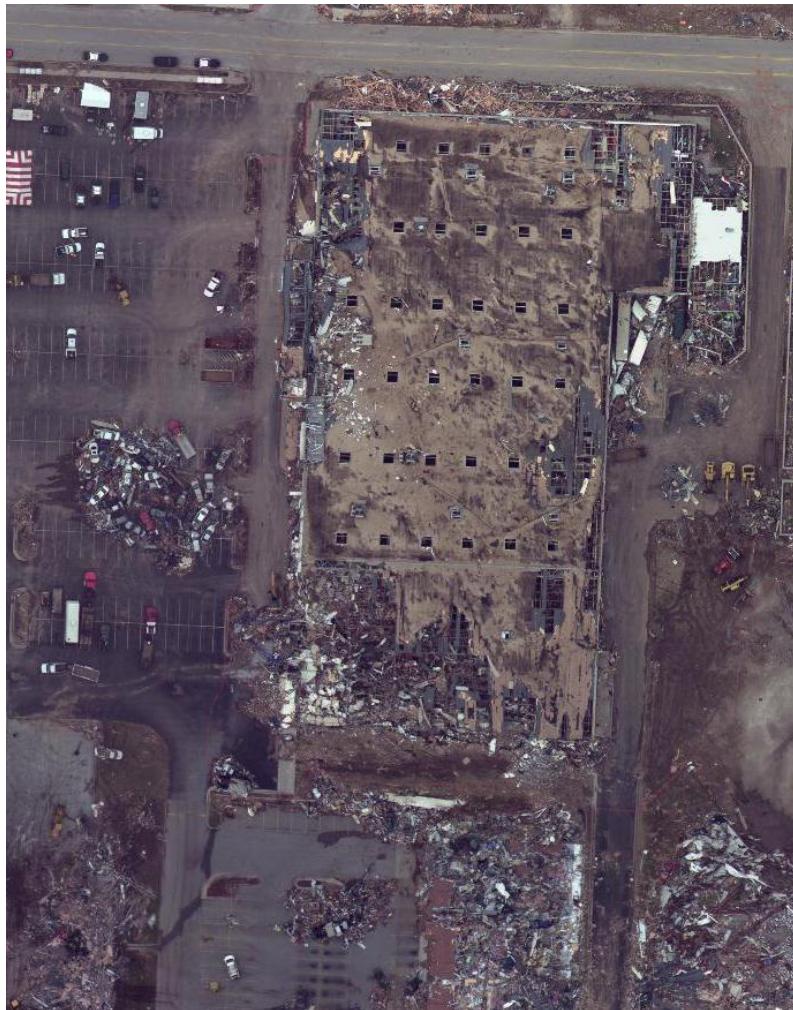
Figure 3 - Academy Sports - Image Credit, Associated Press

The Academy Sports Building, a former K-Mart big-box store, is located at 1717 South Range Line Road. This places it just north of the Home Depot site (center, horizontal arrow in Figure 1) at the northern edge of the catastrophic zone. This building was severely damaged but lost only a portion of its roof (see Figure 3). It was noted that this building was unique in that it has had an 18-gauge roof deck (in lieu of the 22-gauge roof deck as specified on the Home Depot) according to M.A. Carter, P.E.³ He further noted that puddle welds were used as the roof deck to structural connection and expressed an opinion that these connections performed poorly. Puddle welds are susceptible to workmanship since welders may burn through the light gauge deck, which can reduce the deck's capacity.

5. The perception that the Academy Sports performed better is unclear. This former K-Mart building had smaller footprint and an 18 gauge steel roof deck, as compared to a 22 gauge steel deck on Home Depot.³ It also likely had less severe wind load since it was further north from the storm path center.

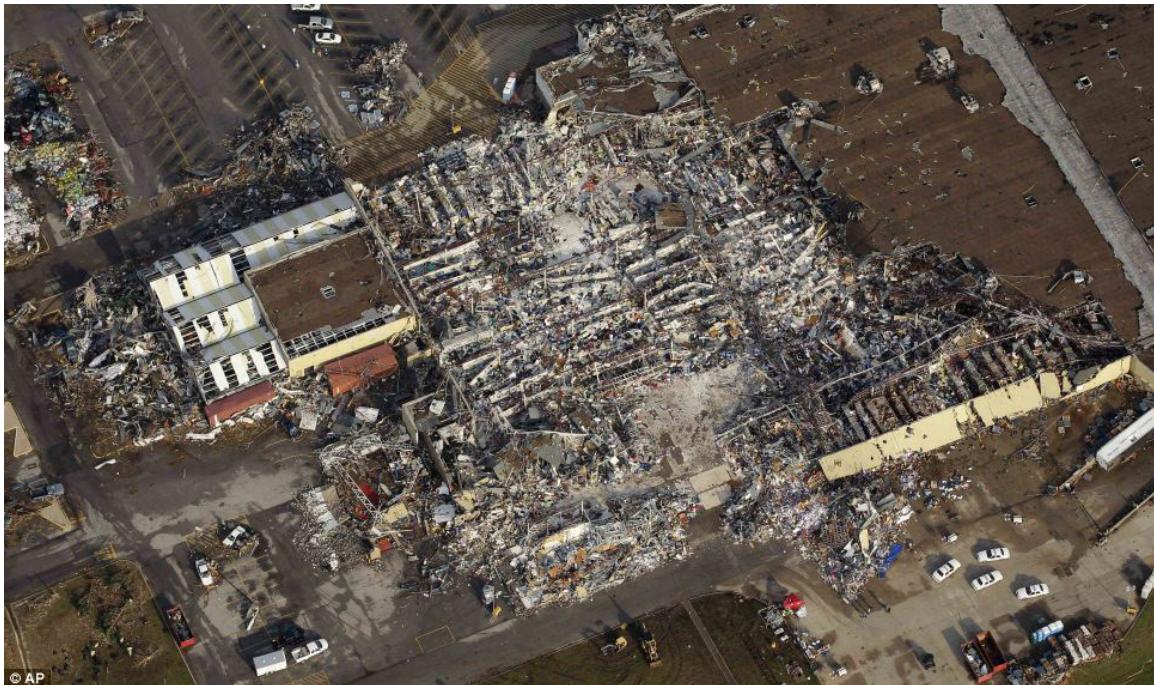
Figure 4 - Wal-Mart - Image Credit, Associated Press

Wal-Mart Store 59 is located at 1501 South Range Line Road, which places the store (top arrow in Figure 1) well north of the catastrophic zone. This is consistent with the thought that it took a glancing blow from the tornado vortex (Figure 4). This point was discussed in a presentation to the Structural Engineers Association of Kansas and Missouri on June 29, 2011 by insurance investigation engineer and Missouri Structural Assessment and Visual Evaluation (SAVE) Coalition volunteer, Thomas Heausler, P.E., S.E.⁷ Both Figure 2 (Home Depot) and Figure 3 (Wal-Mart) show a clear absence of roof deck.

4. The perception that Wal-Mart performed better since it was concrete masonry is false. The Wal-Mart took a glancing blow from the storm and the Home Depot took a direct blow.

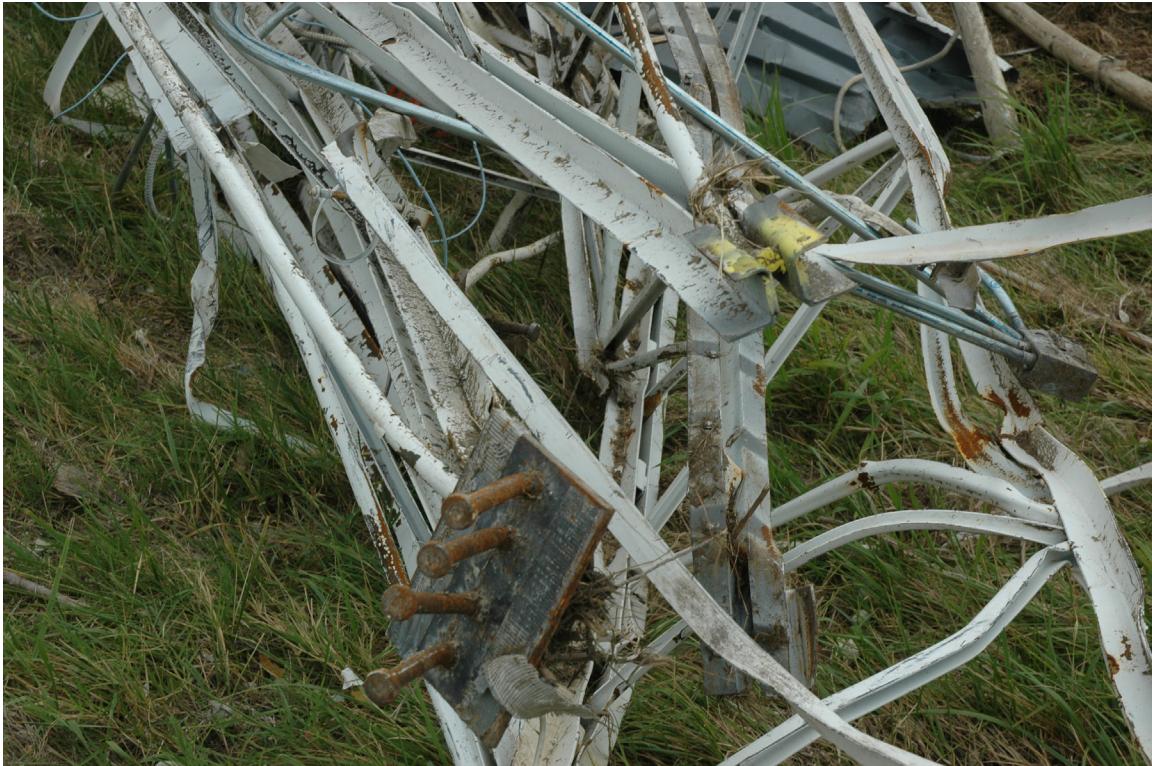
Figure 5 - Typical Joist Seat (CASCO Detail 4/3.1 - Image Credit, Wayne Lischka

Finally, the only indication of failure of a critical embedded item was that provided in The Kansas City Star article. In the graphic used in the newspaper, it is implied that the winds were so strong the anchors were ripped from the walls. The Task Force requested, and was supplied, supporting photos from Mr. Wayne Lischka, P.E., the expert for The Kansas City Star. An example is Figure 5.

It is the opinion of the Task Force that this connection failure was a result of the secondary collapse of the wall panels falling outward from the building on the back wall. This is the only location in the building where a four stud connection was used. In other words, a failure of the roof diaphragm preceded this failure. It is not indicative of a direct uplift pull out failure, but rather the result of the catenary action of the failed roof pulling against the outwardly collapsing panels. As Figure 5 shows, many joist end seats broke free of the embed while a few of the embeds were pried out of the panel.

Task Force: There are no details that show the anchorage as described. The failure of any embedded item in the wall would be a secondary failure due to the collapse and not a cause of the collapse.
