ANALYSIS OF DAMAGE FROM HISTORIC TORNADO IN JOPLIN, MISSOURI, U.S.A. ON MAY 22, 2011

TECHNICAL COMMITTEE

TILT-UP CONCRETE ASSOCIATION

Report 201-12-01

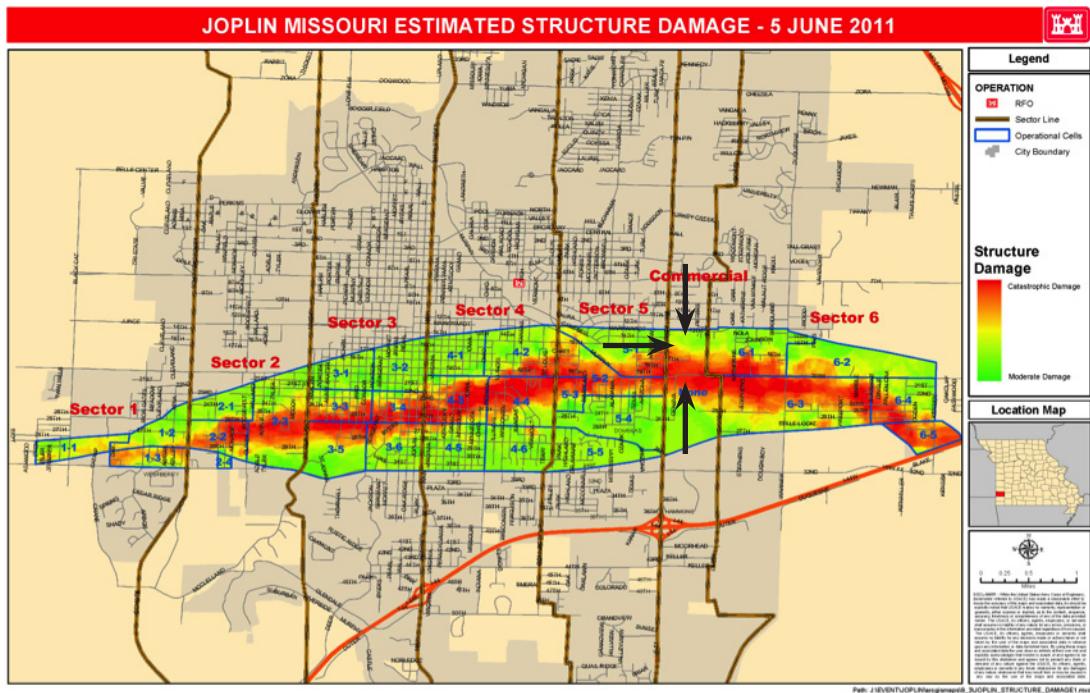
Figure 1 - U.S.A.C.E. Storm Path Damage

An early storm damage/path map from the Army Corps of Engineers is shown as Figure 1. The Home Depot is located at 3110 East 20th Street just east of South Range Line Road (U.S. Route 71). This location places the building directly in the storm path and in the area confirmed on the map as catastrophic damage. Its location is denoted as the lower arrow in Figure 1.

The Academy Sports Building, a former K-Mart big-box store, is located at 1717 South Range Line Road. This places it just north of the Home Depot site (center, horizontal arrow in Figure 1) at the northern edge of the catastrophic zone. This building was severely damaged but lost only a portion of its roof (see Figure 3). It was noted that this building was unique in that it has had an 18-gauge roof deck (in lieu of the 22-gauge roof deck as specified on the Home Depot) according to M.A. Carter, P.E.³ He further noted that puddle welds were used as the roof deck to structural connection and expressed an opinion that these connections performed poorly. Puddle welds are susceptible to workmanship since welders may burn through the light gauge deck, which can reduce the deck's capacity.

Wal-Mart Store 59 is located at 1501 South Range Line Road, which places the store (top arrow in Figure 1) well north of the catastrophic zone. This is consistent with the thought that it took a glancing blow from the tornado vortex (Figure 4). This point was discussed in a presentation to the Structural Engineers Association of Kansas and Missouri on June 29, 2011 by insurance investigation engineer and Missouri Structural Assessment and Visual Evaluation (SAVE) Coalition volunteer, Thomas Heausler, P.E., S.E.⁷ Both Figure 2 (Home Depot) and Figure 3 (Wal-Mart) show a clear absence of roof deck.
